LASER INDUCED DAMAGE TO MIRRORS AT TWO
PULSE DURATIONS

25 July 1972

Technical Report No. 2

E.S. BLISS, CAPT, USAF

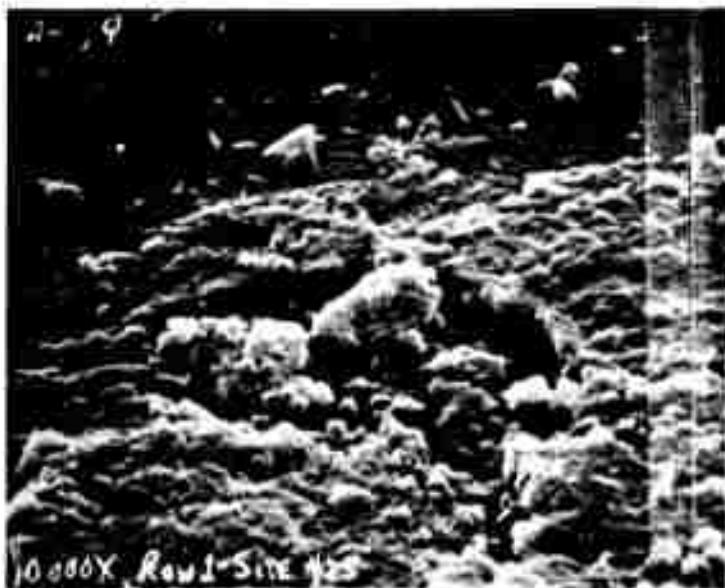
Figure 12. SEM Photograph of the Bright Spot Seen Below and to the Left of Center in Figure 10. The width of the photo is $11 \mu\text{m}$

There is no doubt that small scale local defects can account for some of the damage features reported here. Figures 12 and 14 are examples of pits believed to be caused by the explosion of small absorption centers. It is likely that for mirrors exhibiting a large difference between the practical damage threshold and the perfect coating threshold, small absorbing centers are causing the low level damage. Possible defects include dirt, incompletely oxidized coating material, or some other form of nonuniform deposition. The decrease of practical threshold with increasing beam diameter may be related to the increased likelihood of finding a defect with a large beam. For some mirrors, E-1 for example, the density of small local defects is so high that each one may provide the nucleus for a

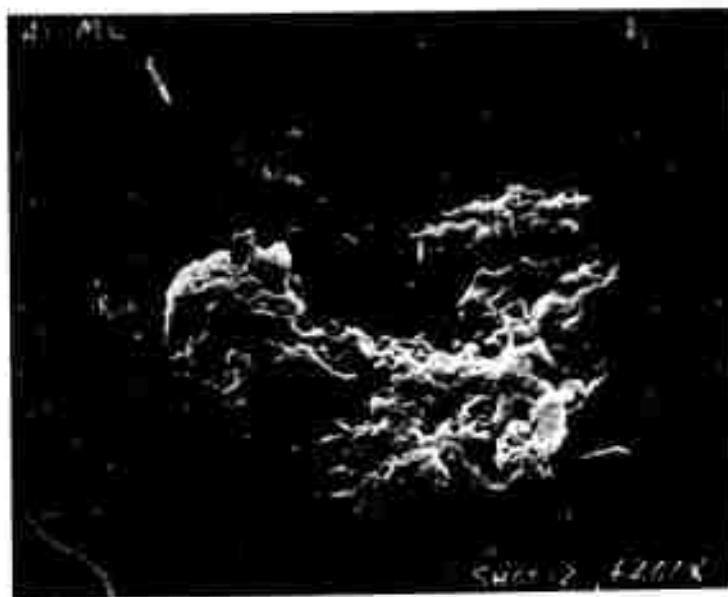
Figure 15. SEM Photograph of the Bright Spot to the Right of Center in Figure 13. The width of the photo is 18 μm

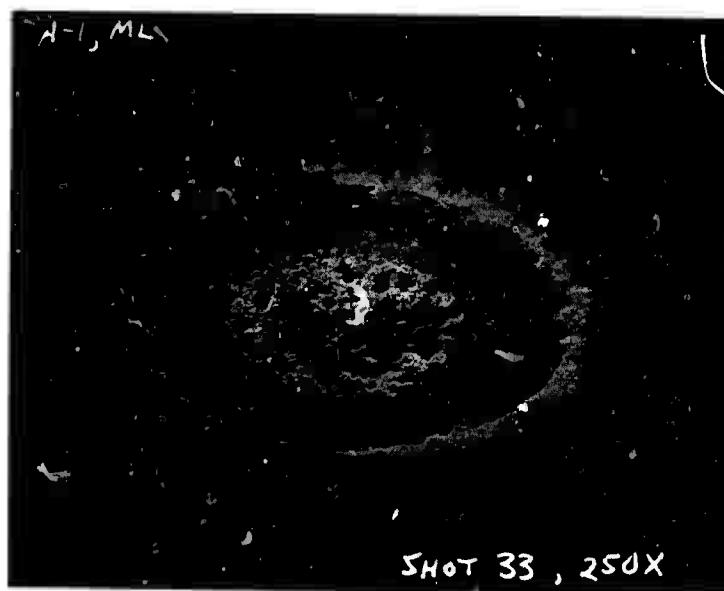
Figure 16. SEM Photograph of a Site Damaged by a Less Energetic 20-psec Pulse. An irregular pattern of material removal is evident in the central portion. The width of the photo is 4.66 μm

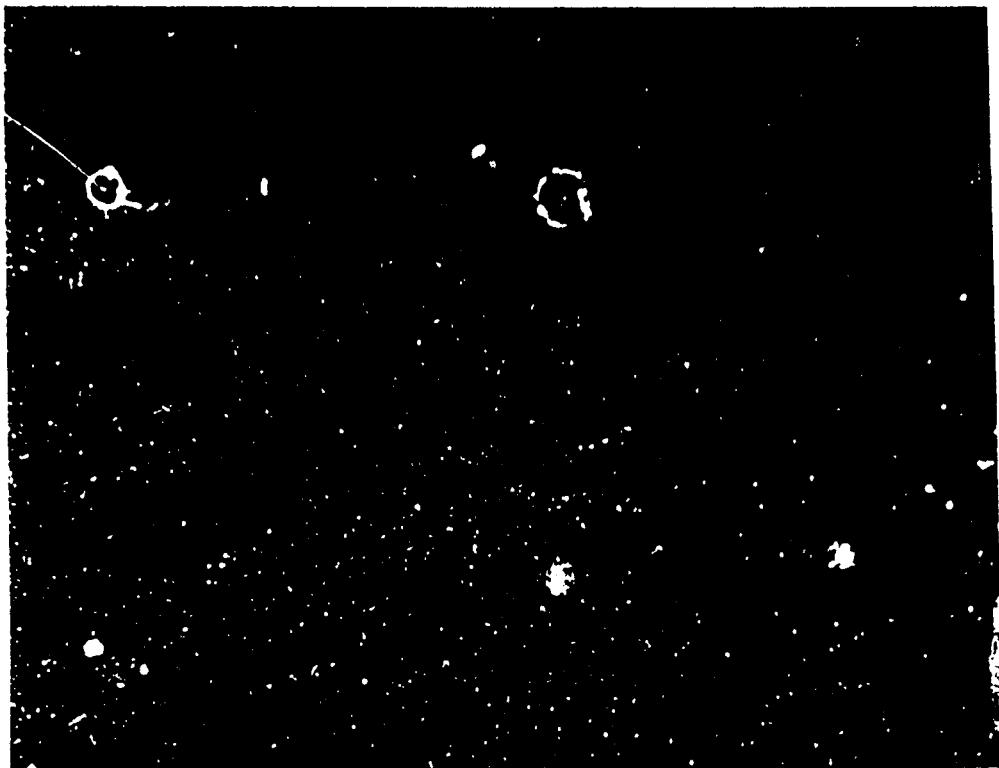
In contrast to the damage site characteristics described above, the affected areas on some mirrors appear under the optical microscope to be made up of a large number of closely packed scattering sites. Two examples of this type of damage are given in the lower right portion of Figure 18. This mirror (E-1) has a generally high density of scattering centers even in areas not exposed to laser radiation, but it is not yet established whether they contribute to the characteristics of the damage sites themselves. The sites just described are produced by 20-psec pulses and the ring type sites on the same mirror in the upper half of the figure are produced by 20-nsec pulses. For mirror B-1 just the opposite is found: 20 psec pulses produce rings and 20-nsec pulses produce scattering centers.

Figure 18. Optical Microscope Photograph of Scattering Site Type of Damage (lower row) Caused by 20-psec Pulse on Mirror E-1, for Which Q-Switched Pulses Produced Mostly Ring Type Damage (upper row). The spacing between the two sites in the right side of the lower row is 1 mm

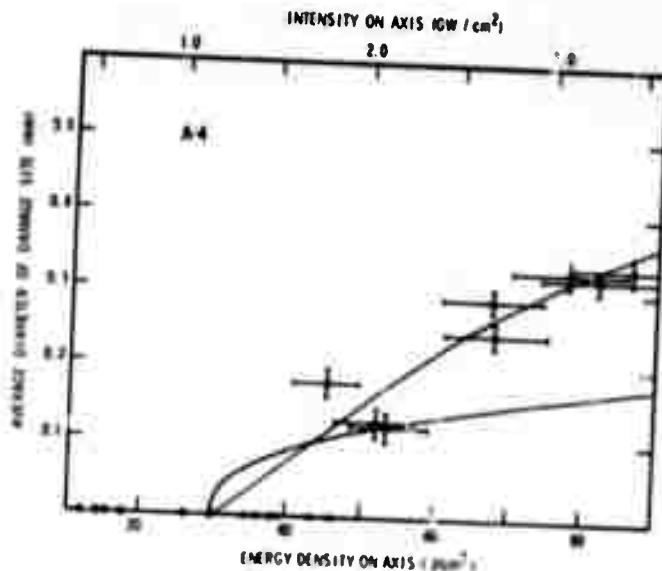
A convenient way to display the mirror damage data is on a plot of damage site diameter vs the pulse energy density on axis. Figure 20 shows such a plot for the Q-switch pulse damage tests on mirror A-4. For low enough energy densities no evidence of damage is found (\circ). For energy densities above 30 or 35 J/cm^2 some randomly located small scattering centers are created, but there is no well-defined pattern to which a diameter can be assigned (Δ). Finally, for energy densities above about 45 J/cm^2 well-defined damage sites develop with diameters that are larger for more energetic pulses.

From such data two kinds of thresholds can be defined, the "practical damage threshold" below which no damage is caused by a single shot and a higher idealized threshold, a "perfect coating threshold", below which damage seems to be associated with local flaws of some sort rather than w'th inherent coating limitations. In Figure 20 the curve through the data is drawn to intersect the density axis at a point corresponding to the practical threshold. A curve drawn through the perfect coating threshold would intersect the axis at about 45 J/cm^2 and rise more steeply to pass through the remaining data points.

Figure 20. Damage Site Diameter vs Q-Switched Pulse Energy Density on Axis for Mirror A-4. Shots causing no detectable damage are indicated by (O), those causing only randomly located small scattering centers by (Δ), and sites with well-defined diameters by (O) at finite diameter values. A curve is drawn through the data points to intersect the axis at the practical damage threshold. The second curve gives the damage site diameter predicted on the assumption that any place on the coating will damage when subjected to an energy density of 30 J/cm^2

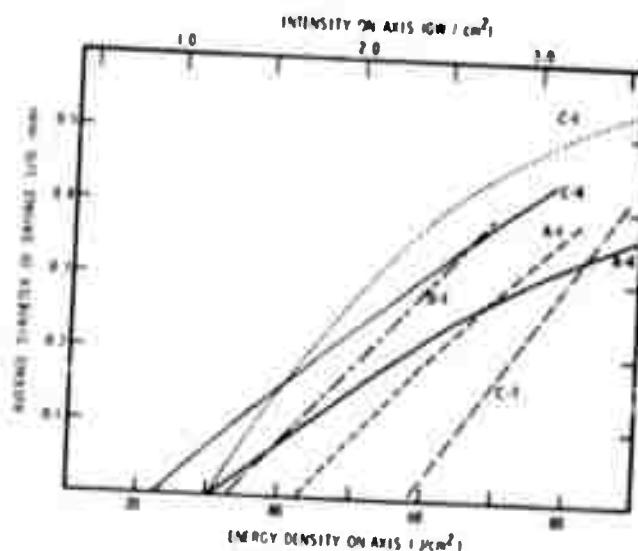
Plots of measured site diameter vs Q-switched on-axis energy density for six of the nine mirrors are shown (without data points) in Figure 21. The curves are drawn to cross the axis at the practical damage threshold, and in general the perfect coating threshold is higher as seen in Table 2. All of these curves show damage sites that are larger at high energy than predicted by the simple constant-energy density assumption discussed above.

Figure 21. Damage Site Diameter vs Q-Switched Pulse Energy Density on Axis for Six Mirrors

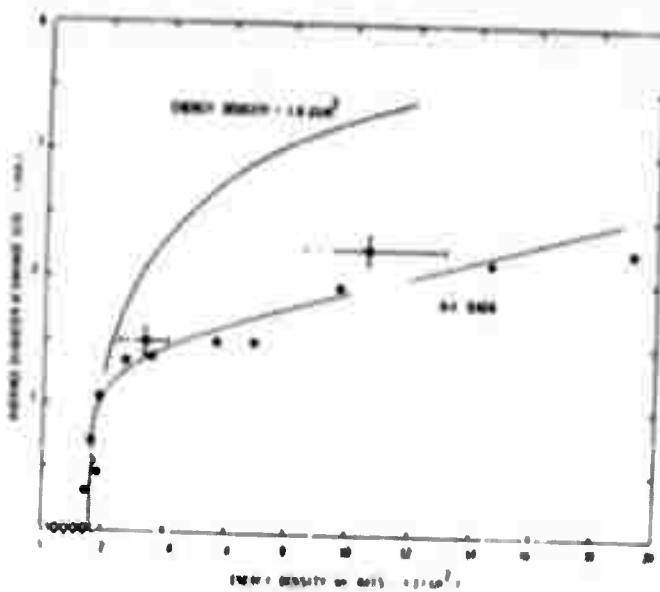
Plotting the data from damage tests with single mode-locked pulses gives similar curves. There are some notable differences, however. First, all of the detected damage sites have measurable diameters, eliminating the distinction between the two threshold definitions discussed above. Second, a sharp rise in the curve immediately above threshold is clearly established by the data for most of the mirrors. Finally, for all but two of the mirrors, the damage sites are smaller at high energy than predicted by the constant energy density assumption. These differences are evident in Figure 22.

Figure 22. Damage Site Diameter vs 20-psec Pulse Energy Density on Axis for Mirror A-1. Shots causing no detectable damage are indicated by (X) and those causing damage by (●). The error bars shown are typical.

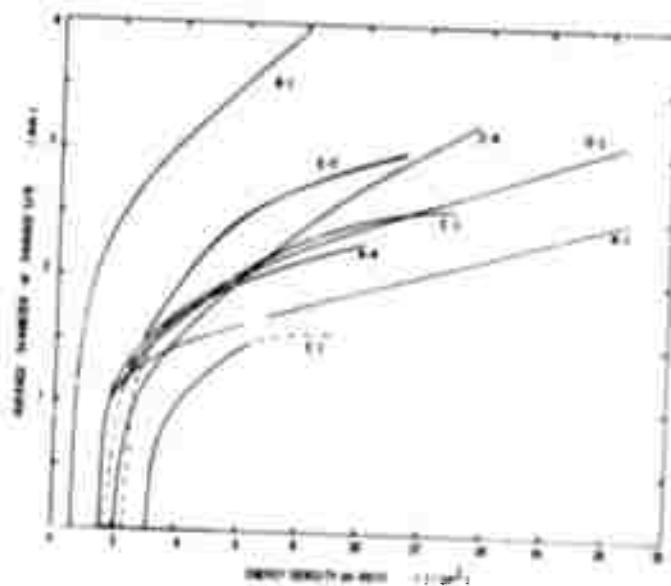
Plots of measured site diameter vs the on-axis energy density of the 20 psec pulse for seven of the mirrors are shown (without data points) in Figure 23. Mirrors B-1 and C-7 are exceptions in that they do fit a constant energy density curve quite well. Table 2 summarizes the results.

Figure 23. Damage Site Diameter vs 20-psec Pulse Energy on Axis for Seven Mirrors

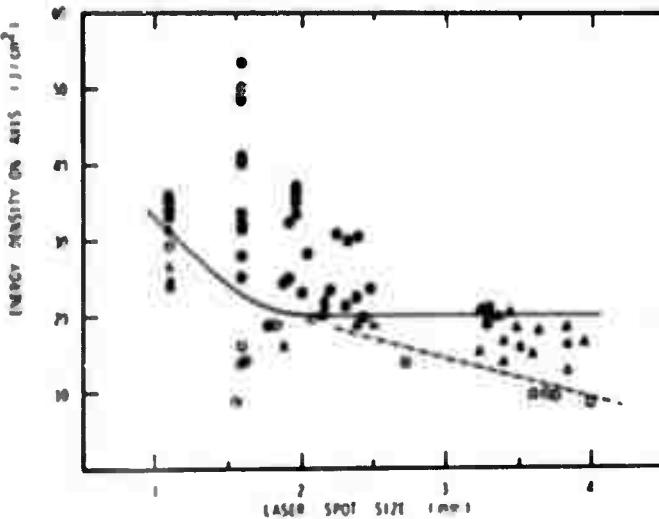
To determine whether the observed damage threshold for 20-psec pulses measured with a 197- μm beam diameter can be meaningfully compared with the threshold for 23-nsec pulses measured with a 130- μm beam diameter, it is necessary to perform damage tests over a range of beam diameters at a fixed pulse duration. The results of such an investigation for mirror A-6 with 23-nsec pulses are shown in Figure 24. As in Figure 20 two kinds of thresholds are evident, at least for the large diameter beams, and so two curves are drawn,

Figure 24. Q-Switched Damage Threshold vs the Beam Diameter at Half the On-Axis Energy Density for Mirror A-6. Shots causing no detectable damage are indicated by (O), those causing only randomly located small scattering centers by (Δ), and sites with well-defined diameters by (●). The solid curve indicates the best estimate for the variation of the perfect coating threshold, and the dashed curve the best estimate for the variation of the practical threshold

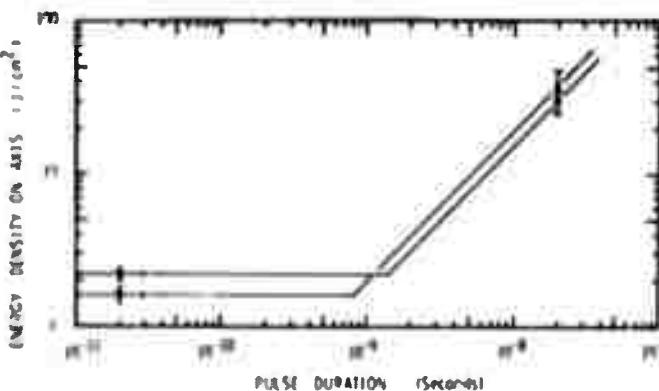
Figure 25. Single Pulse Damage Threshold vs Pulse Duration for Mirrors A-1 and A-4. The curves are drawn to fit the functional form suggested by theoretical considerations discussed in Section 5.4

Even allowing for possible 25 percent reductions of the Q-switched damage thresholds in Table 2 if the measurements had been made with a 197- μm beam diameter as the 20-psec measurements were, the 23-nsec values are from ten to thirty times higher than the 20-psec energy density thresholds. Figure 25 illustrates this general observation with the results from mirrors A-1 and A-4. In this plot no adjustment for beam diameter dependence has been made since the size of such a correction could only be inferred from measurements on a different mirror. It is likely, however, that the Q-switched values should be recorded at a somewhat lower energy density. In this figure the functional form of the curves is suggested by theoretical considerations discussed in Section 5.4.
